TECHNICAL REPORT ARPAD-TR-84007

**ULTRASONIC INSPECTION OF ALLOYED TUNGSTEN BARS**

**HENRY HARTMANN**

**NOVEMBER 1984**

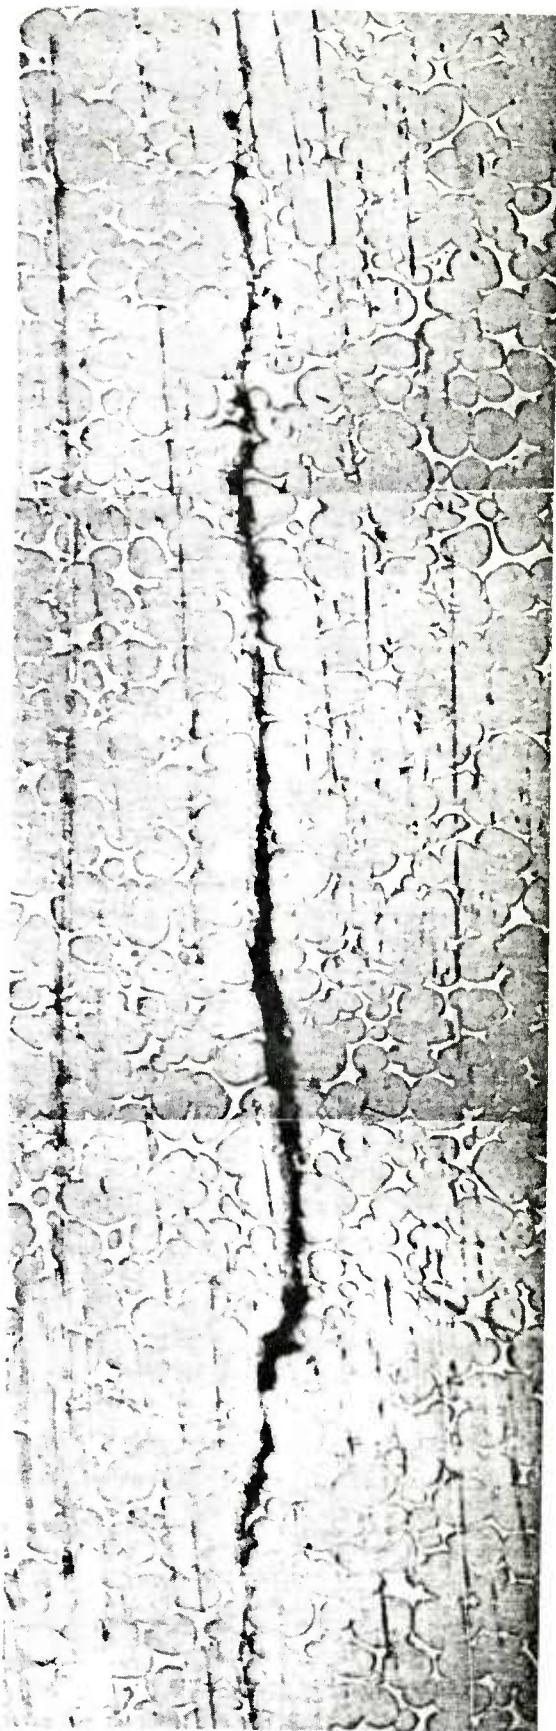
Of the hundreds of round bars ultrasonically inspected, only one was found to contain a defect. This bar had a crack near one end (fig. 2).

Of the approximately 200 Teledyne made alloyed tungsten bars that were ultrasonically inspected, only one bar was encountered that had an alarm-ringing flaw. A longitudinal wave scan of the bar had failed to detect a flaw, but the diagonal shear waves located a flaw 23 mm (0.9 in.) in from one of the ends of the bar. The flaw behaved like a crack, exhibiting unidirectional reflectivity. Careful machining revealed that the flaw was a crack approximately 2 mm (0.08 in.) long (shown in fig. 2). Note that the crack did not go through any of the powdered metal particles. The crack skirted the round particles.

When compared to the size of detection signals from the two standards, the maximum detection signal from this crack fell in between. Interpolation reveals that a 2.7 mm (0.106 in.) diameter hemispherically-bottomed hole in a third standard would echo the same amplitude of detection signal as the peak signal received from the crack.

The crack lies approximately one-third of the way into the bar and faces the ends of the bar.

Figure 2 shows more than a crack. Notice all the void space between the metal particles. This region has a low density and is weak. So weak that a crack occurred during swaging.

Figure 2. Crack in an alloyed tungsten bar

Determine the critical crack size in alloyed tungsten metal so that proper ultrasonic inspection standards can be used.

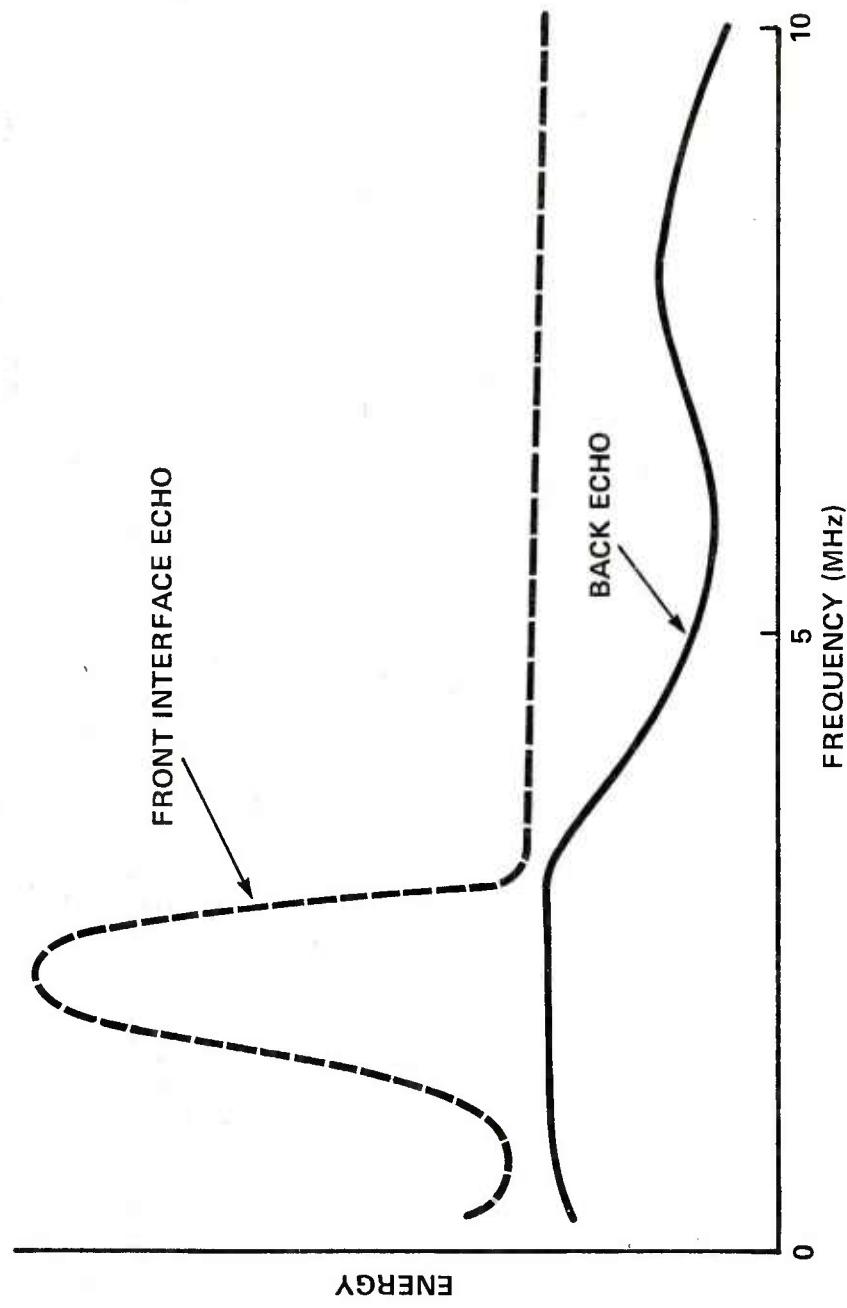
Any kind of sintered material made from powdered metal will be noisy during an ultrasonic inspection. For a given material, lower frequency ultrasound generates less noise. A frequency of 2.25 megahertz (MHz) was tried with good results. An immersion 2.25-MHz narrowband, 0.375-inch-diameter flat lens transducer was used to pulse ultrasound through water and down through the length of an alloy tungsten bar. A Hewlitt-Packard Model 8557A Spectrascope revealed the front interface and back echoes which are superimposed in figure 3. The front interface echo contained peak energy at a frequency spread of 2.2 to 2.3 MHz (which was to be expected). The back echo from the far end of the bar (after the pulse went down through the bar and back) contained peak energy between 2 to 4 MHz. This revealed that a substantial portion of the tuned energy in the region of 2.25 MHz was bringing back information about conditions inside the bar.

Figure 3. Frequency distribution of a 2.25 MHz pulse going into and coming out of an alloyed tungsten bar

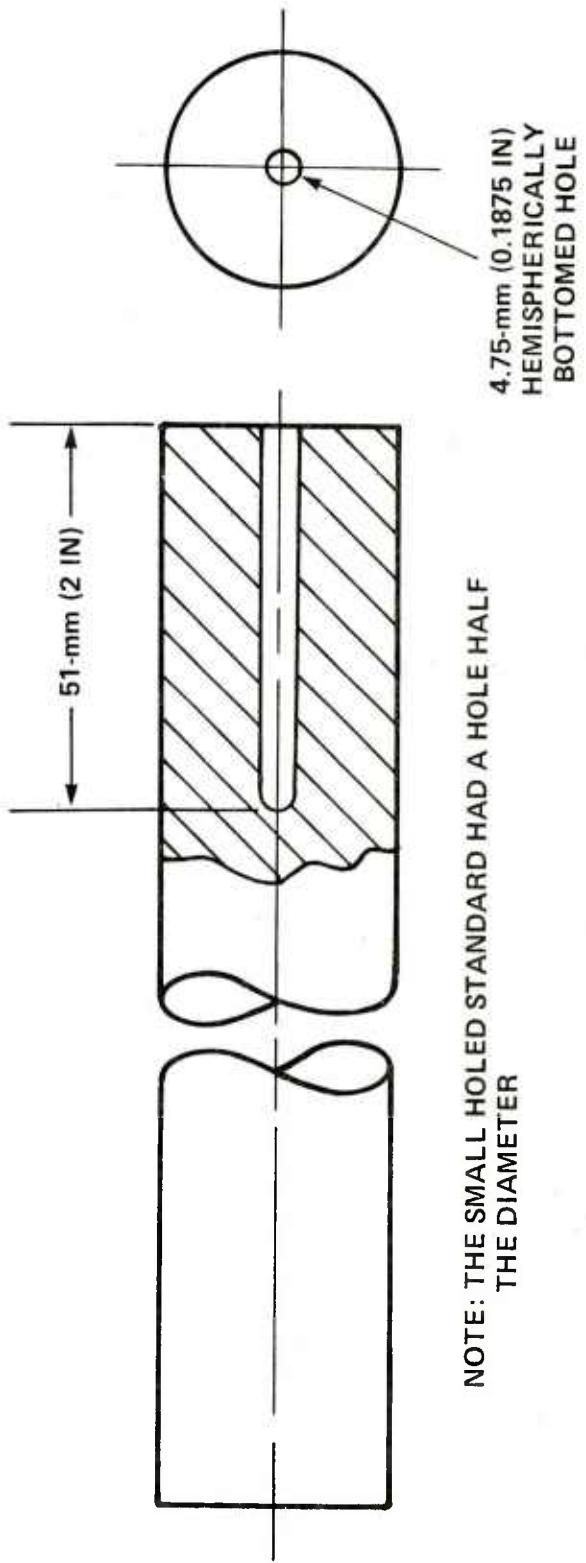
It is difficult to design a standard when the size and type of defect are unknown. The problem is complete lack of experience and lack of data with sintered alloyed tungsten material. No one contacted knew what geometry of defect was expected to cause a problem. The target that was used to simulate a yet-to-be-established defect is illustrated in figure 4. The target consisted of a hemispherically bottomed hole drilled along the axis of a bar. A spherical target provides a uniform reflective surface to any ultrasound pulse coming diagonally across or straight down the bar.

Figure 4. The large holed standard

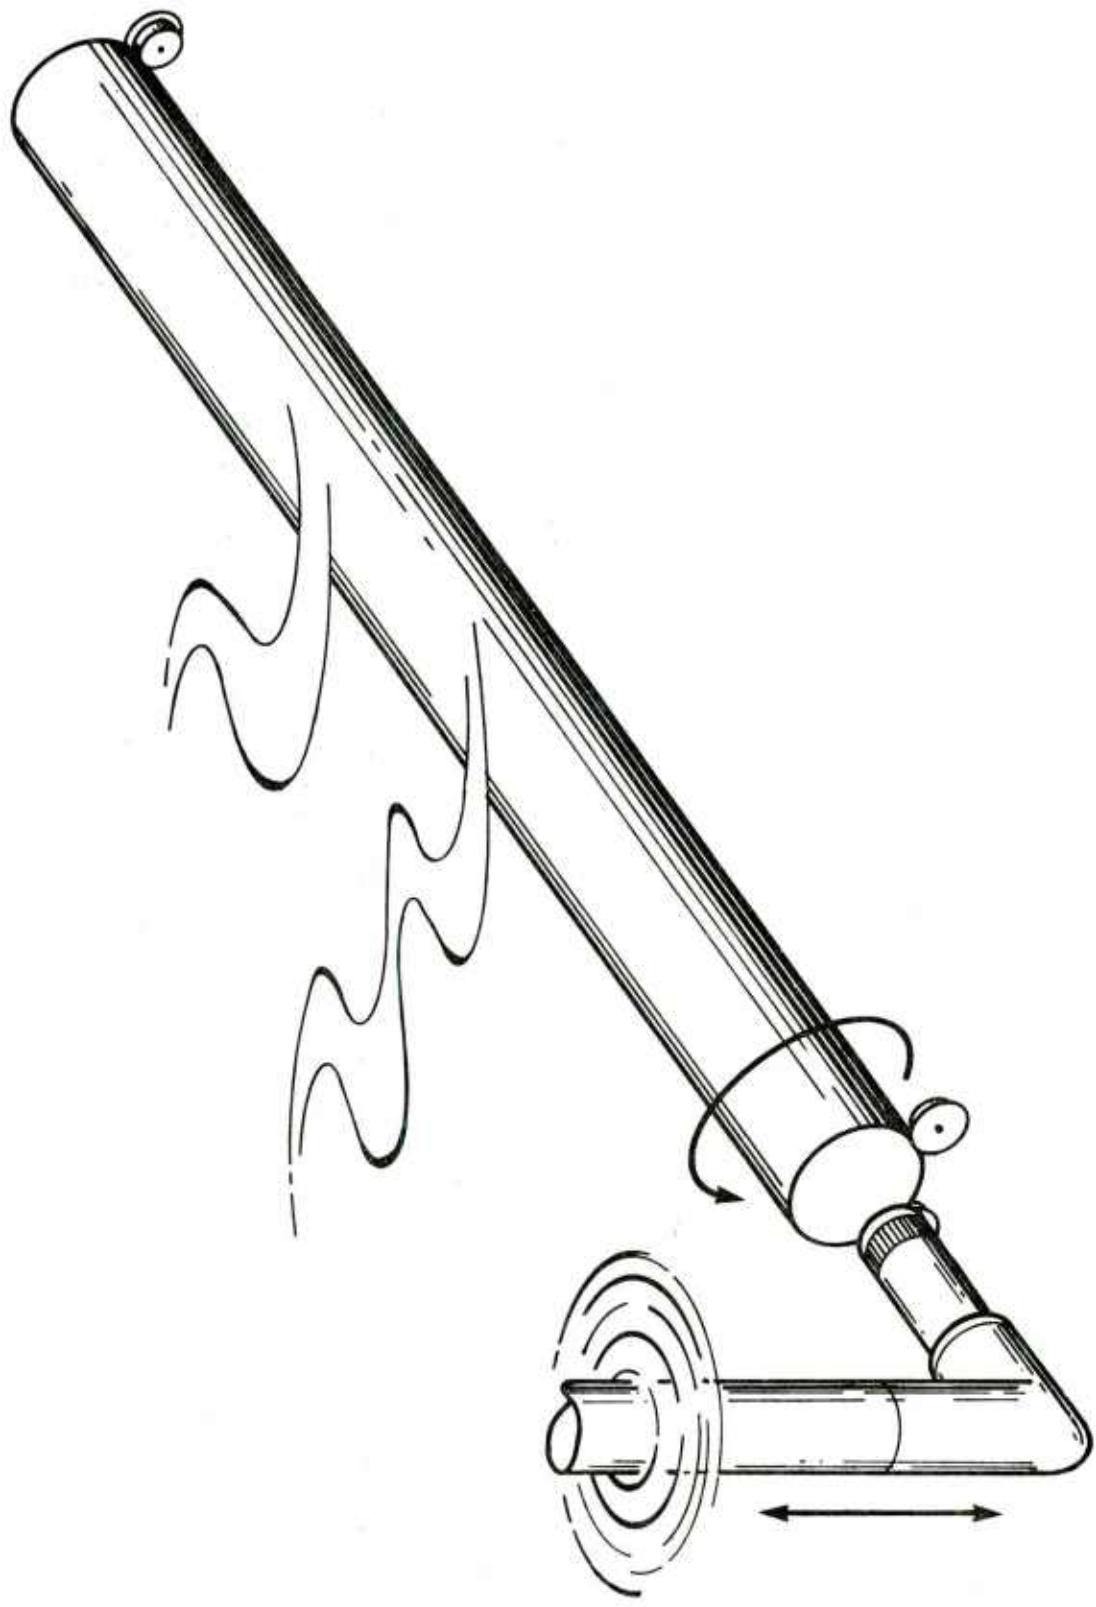
**Arrangement of Ultrasonic Transducer.** Figure 5 shows the arrangement of the ultrasonic transducer relative to the bar. The inspection was done under water. Longitudinal waves of ultrasound were used. Ringing of the water-to-metal interface signal was difficult with this arrangement. The problem was that the duration of ringing could last during the entire time that the pulse was in the length of the bar. By shortening the water path; that is, moving the transducer close to the rear end of the bar, the duration of ringing was shortened. Waterpaths of 1 to 2 mm (0.04 to 0.08 in.) permitted ultrasonic inspection of the far half of a bar. As a result, every bar had to be inspected through both ends (one end at a time) so that all of the metal could be ultrasonically interrogated.

Figure 5. Ultrasonic inspection directly down the length of an alloyed tungsten bar

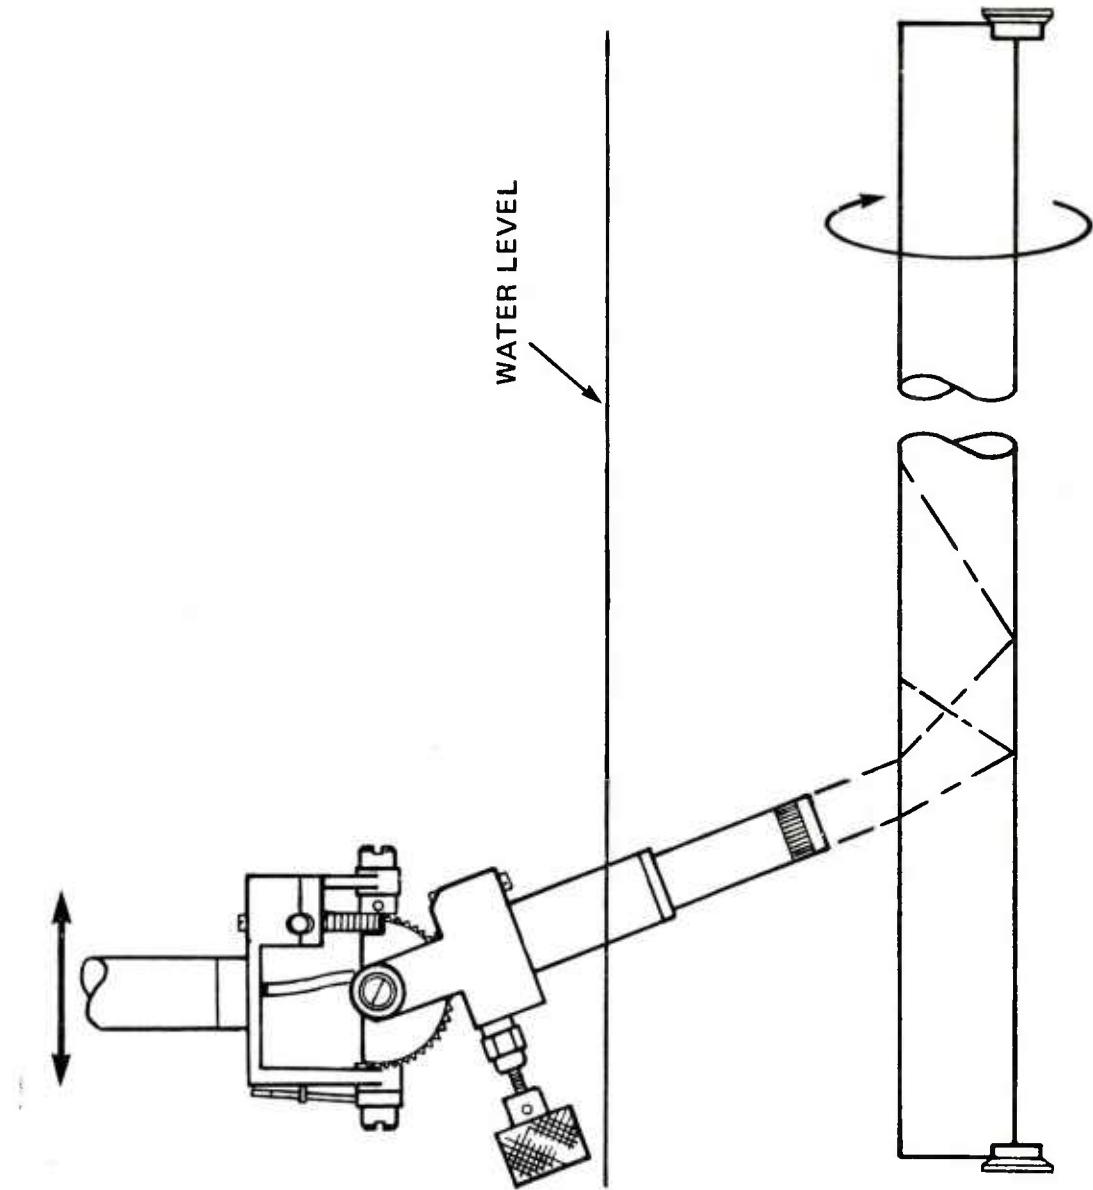
**Arrangement of Ultrasonic Transducer.** The arrangement of an ultrasonic transducer relative to a bar is shown in figure 6. Ultrasound pulses emanating from the transducer traveled through the water, converted to shear waves upon entrance into the alloyed tungsten bar, and traveled diagonally across the bar. Dotted lines give a general idea of the path of ultrasound.

Figure 6. Ultrasonic inspection diagonally across an alloyed tungsten bar
